THE M1 ABRAMS BATTLE TANK

Text and colour plates by Steven J. Zaloga

OSPREY PUBLISHING LONDON

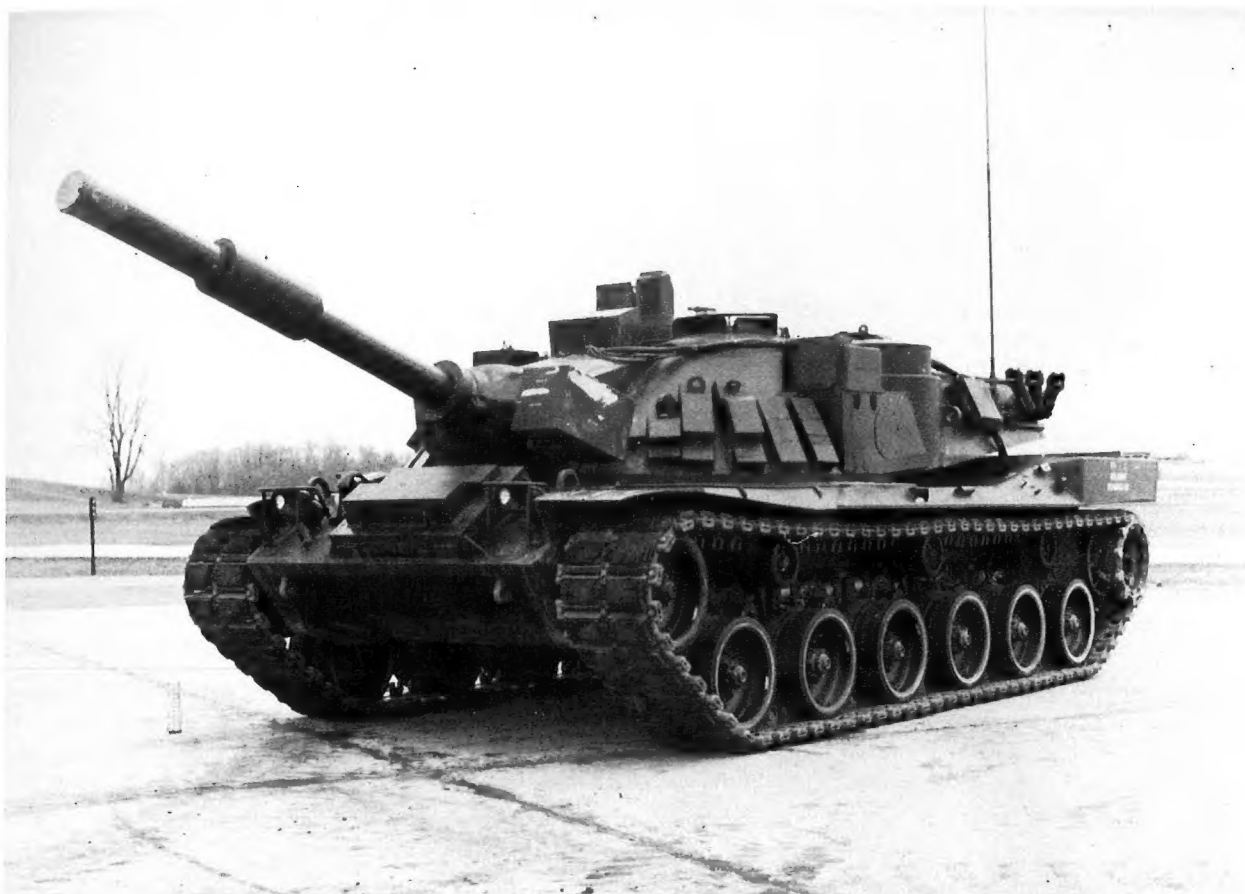
The ill-fated American-German MBT-70 programme ground to a halt in the late 1960s due to rising costs and technological problems in the design. This was excessively complex, and incorporated an automatic loader, hydropneumatic suspension, a guided missile/gun system, full CBR suite, a remote control AA gun, and a host of other systems which proved technologically immature. (US Army)

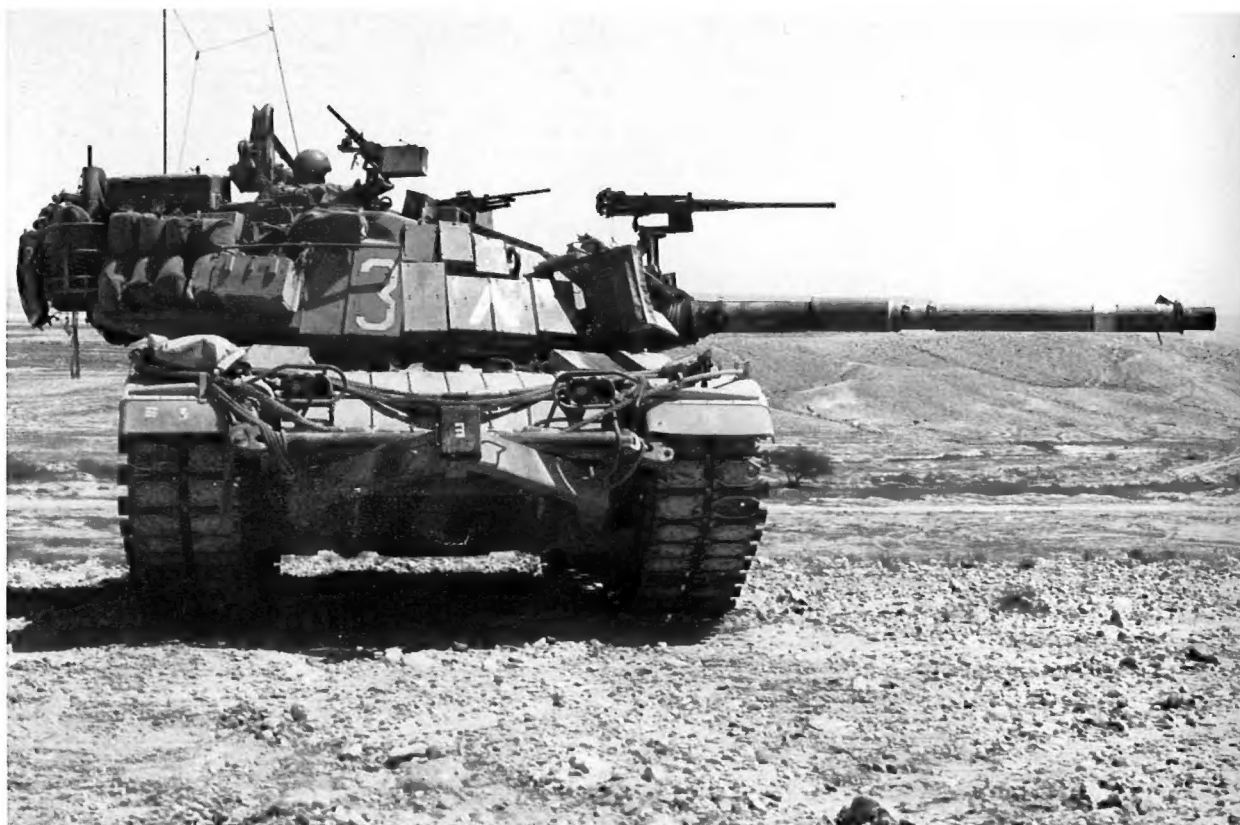
This Israeli M60A1 is fitted with the Blazer reactive armour system, which was first deployed in the 1982 invasion of Lebanon. This type of appliqué armour was developed mainly as a stop-gap solution to the threat posed by hand-launched anti-tank rockets like the RPG-7 in crowded urban battle-grounds. (Zahal)

real hazard to crewmen who may have their heads exposed when the active armour is detonated, and to nearby friendly infantry. The Israeli Army deployed an active armour system known as Blazer on its M60A1 and Centurion tanks in the 1982 invasion of Lebanon. The system was not without its shortcomings, but was felt useful in spite of the problems due to the threat from RPG-7s in the confined urban areas of Lebanon.

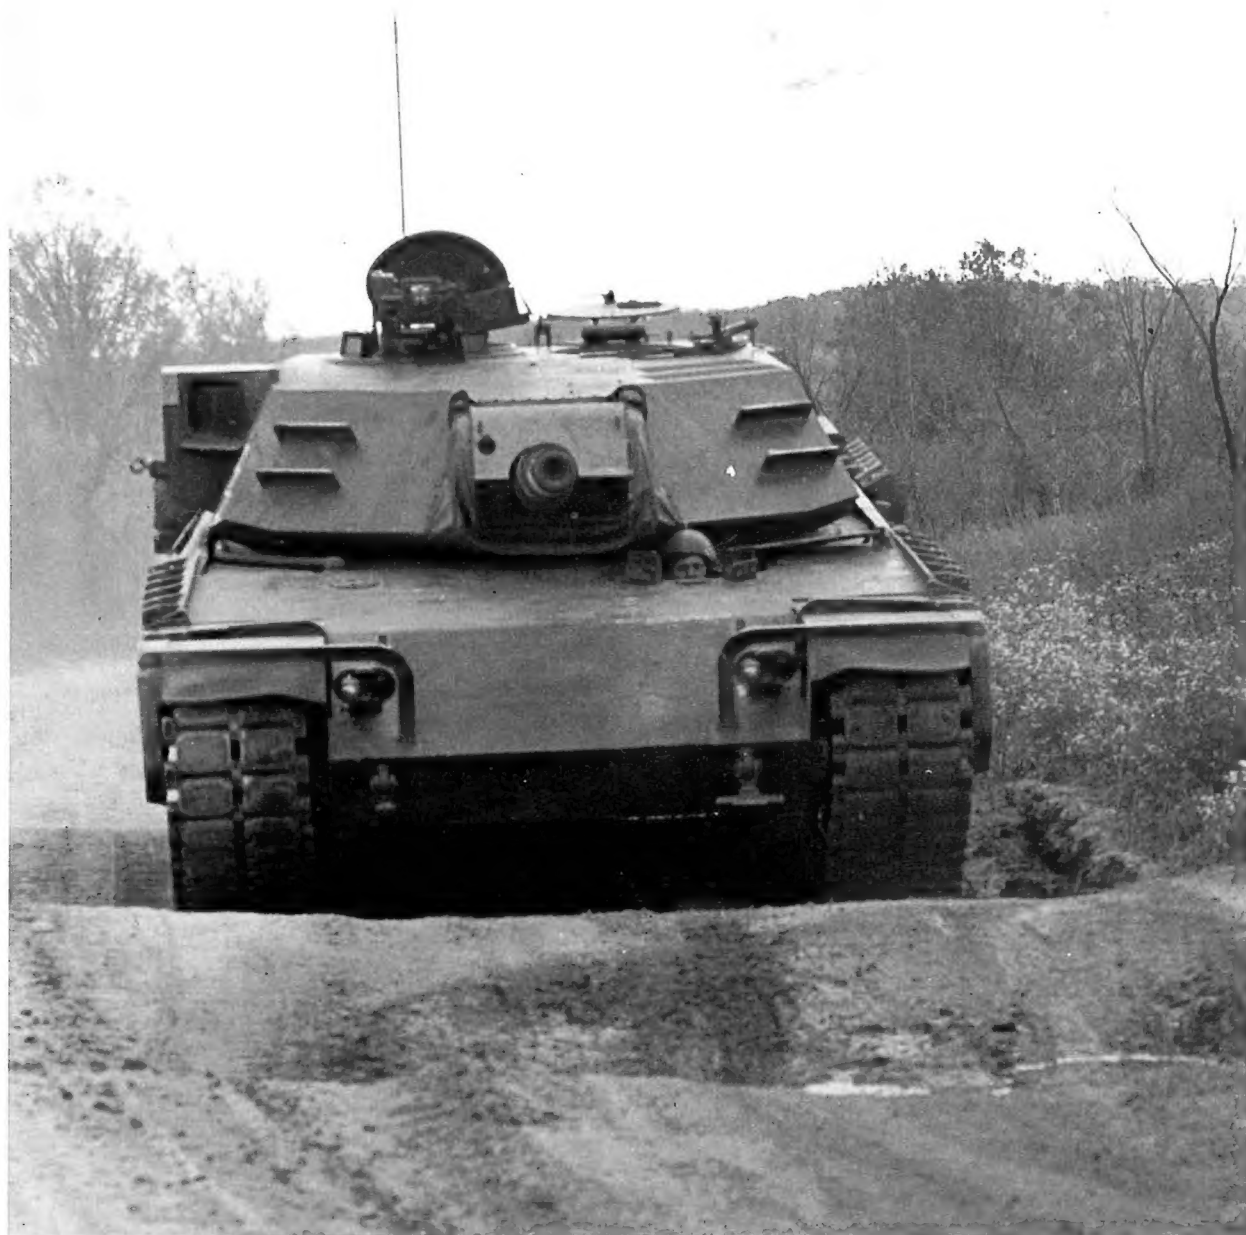
The prototype of the GM entry in the XM1 competition. In contrast to the Chrysler design, the GM version had a diesel engine. Note also that the thermal sight is located on the hull side rather than the roof. Chrysler's Defense Division was later sold to General Dynamics, who now run the M1 production facilities at Lima and Detroit as General Dynamics Land Systems Division. (GM)

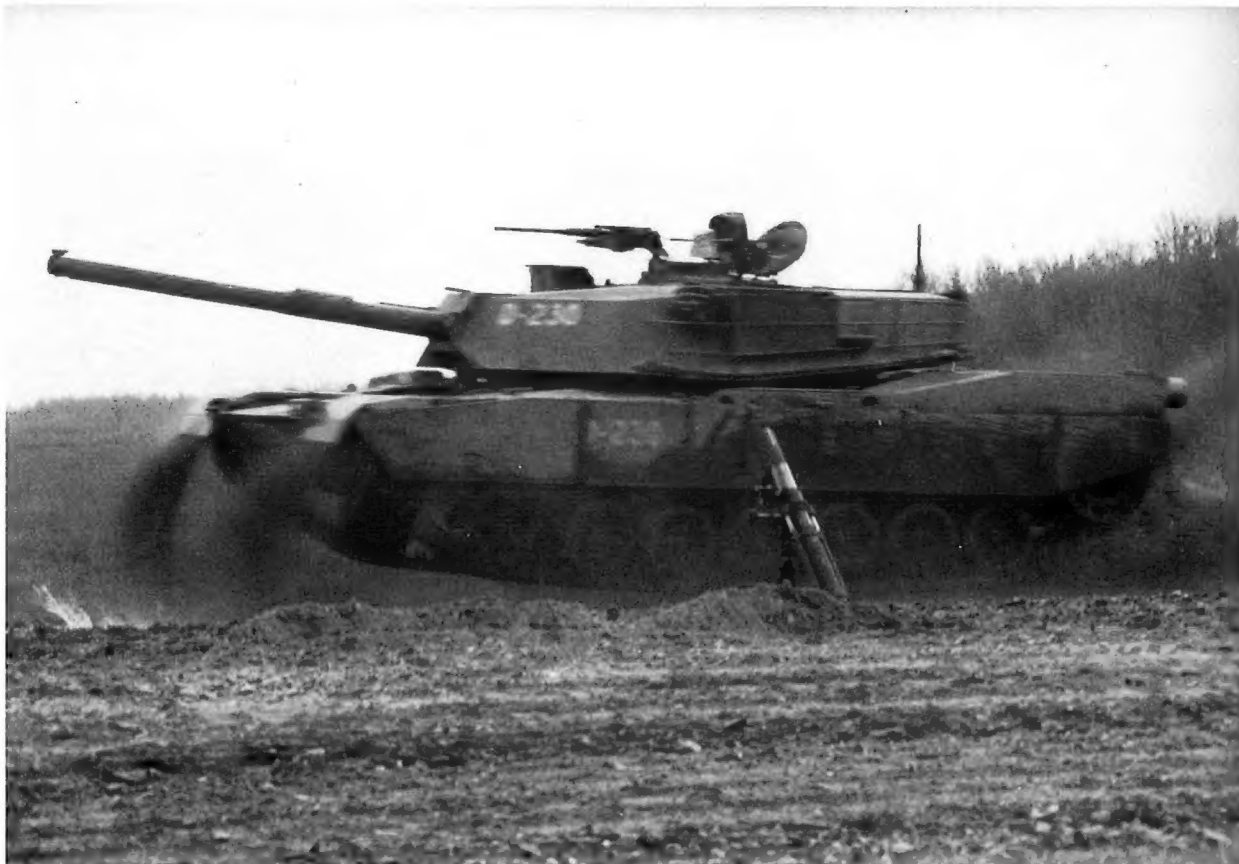
A major requirement in the M1 design was high speed: a vehicle moving cross-country at high speed is difficult to hit, and a faster vehicle is also able to exploit battlefield situations better than a slower tank. This M1 at the Aberdeen Proving Grounds (APG) literally leaps over a small embankment while travelling at its top governed speed of about 45 mph. 'D-230' indicates the 230th production vehicle from the Detroit Tank Arsenal. (S. Zaloga)

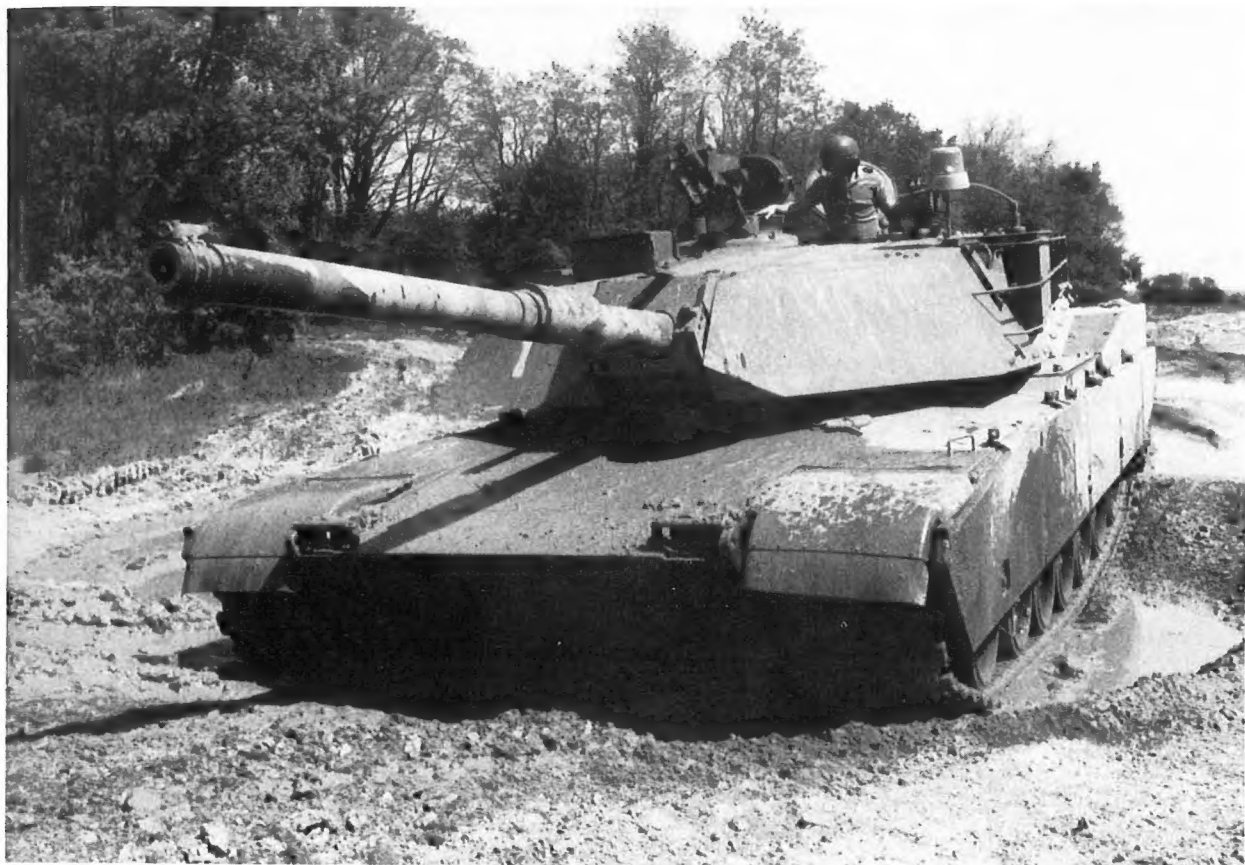
Although the M1 is already in full-scale production, testing still continues at APG and other locations to ensure that the various technical 'fixes' selected during trials do work as planned. This mud-soaked vehicle has just gone through fording tests. (Michael Green)

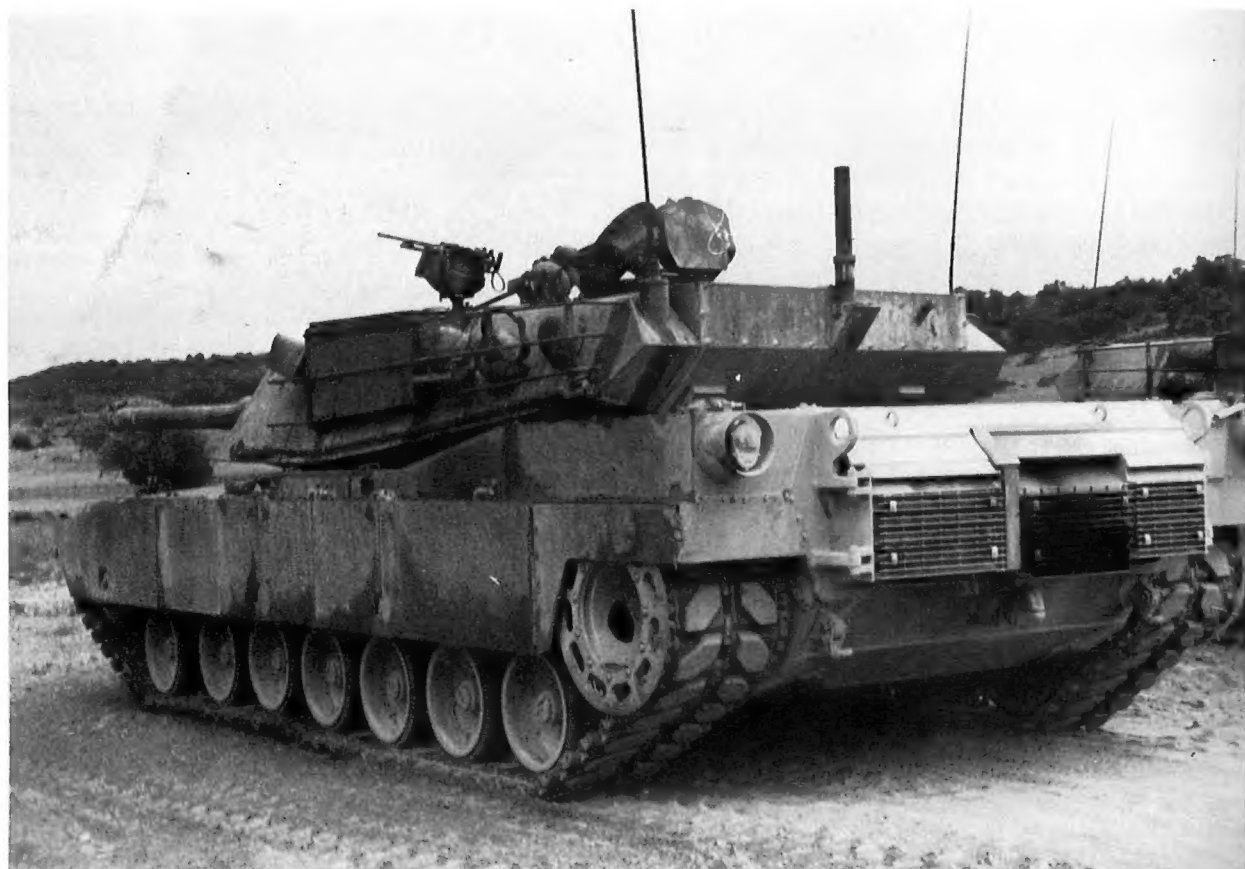
Field use has led to the adoption of a number of 'fixes'. This M1 of the 2nd Armd. Div. shows the cut-out rear skirts adopted by the division and other units to prevent mud from the drive sprocket becoming impacted. This rear view also shows some of the minor changes in configuration of the rear exhaust louvres in the intermediate production vehicles. The vertical post on the turret rear is the gun system wind sensor. (S. Zaloga)

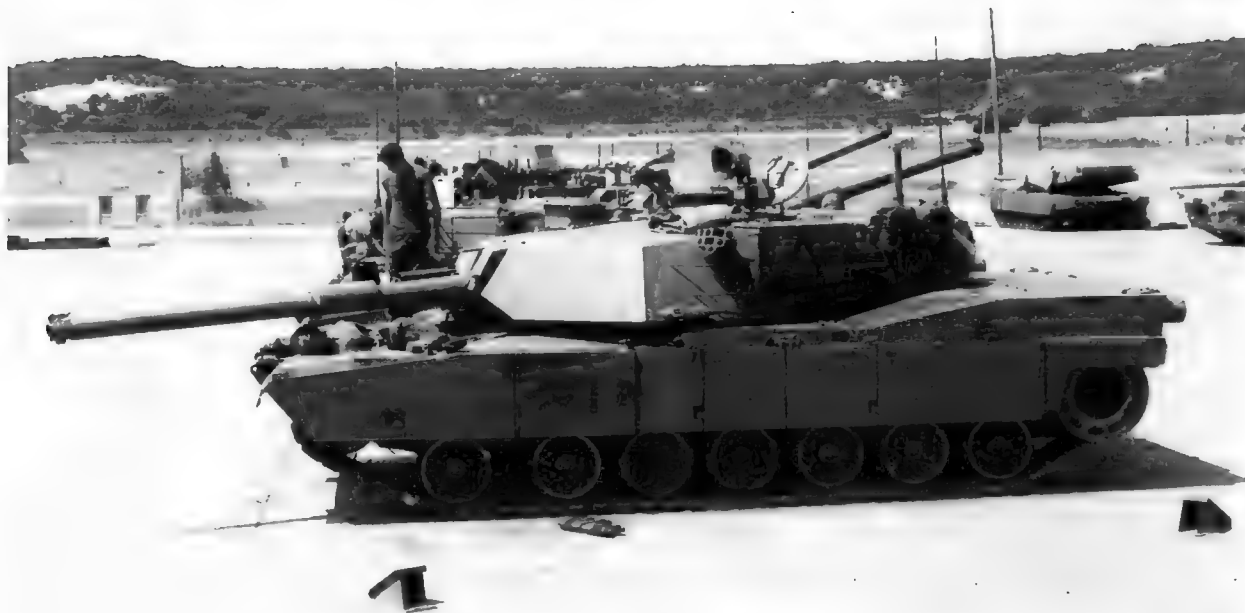
The first division to be completely re-equipped with the M1 was the 2nd Armored at Ft. Hood, Texas in 1982-83. This M1 belongs to 3/67 Armor, as is evident by its 'Hounds-of-Hell' insignia on the side skirts. (S. Zaloga)

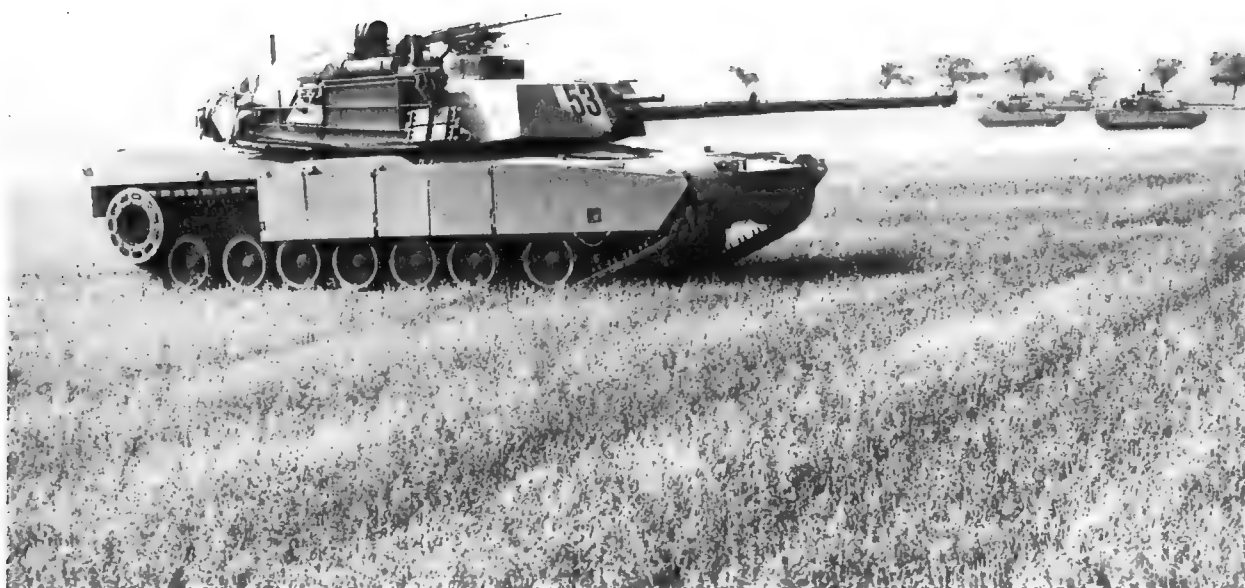
A company of M1s of 64th Armor spread out in battle formation during the 1982 'Reforger' exercises. The successful employment of the M1 in this exercise was the first clear vindication of the Army's decision to stick with the M1 despite exaggerated Press criticism. (Pierre Touzin)

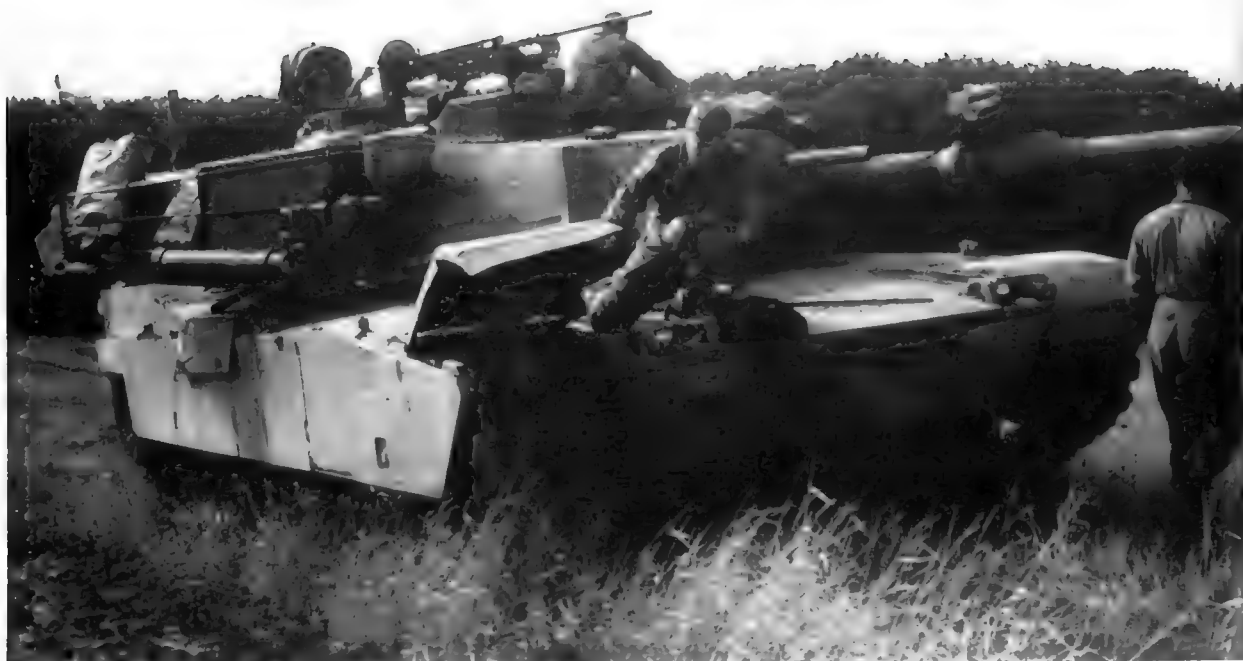
The eternal chore of tankers is tank maintenance. Unlike the family car, a tank requires several hours of work by the crew each day to check oil and lubricant levels, filters, track tension, and a host of other things. This is an M1 of 11 ACAV during the initial phases of 'Reforger' 1983, before the mud camouflage was applied. (Arnold Meisner)

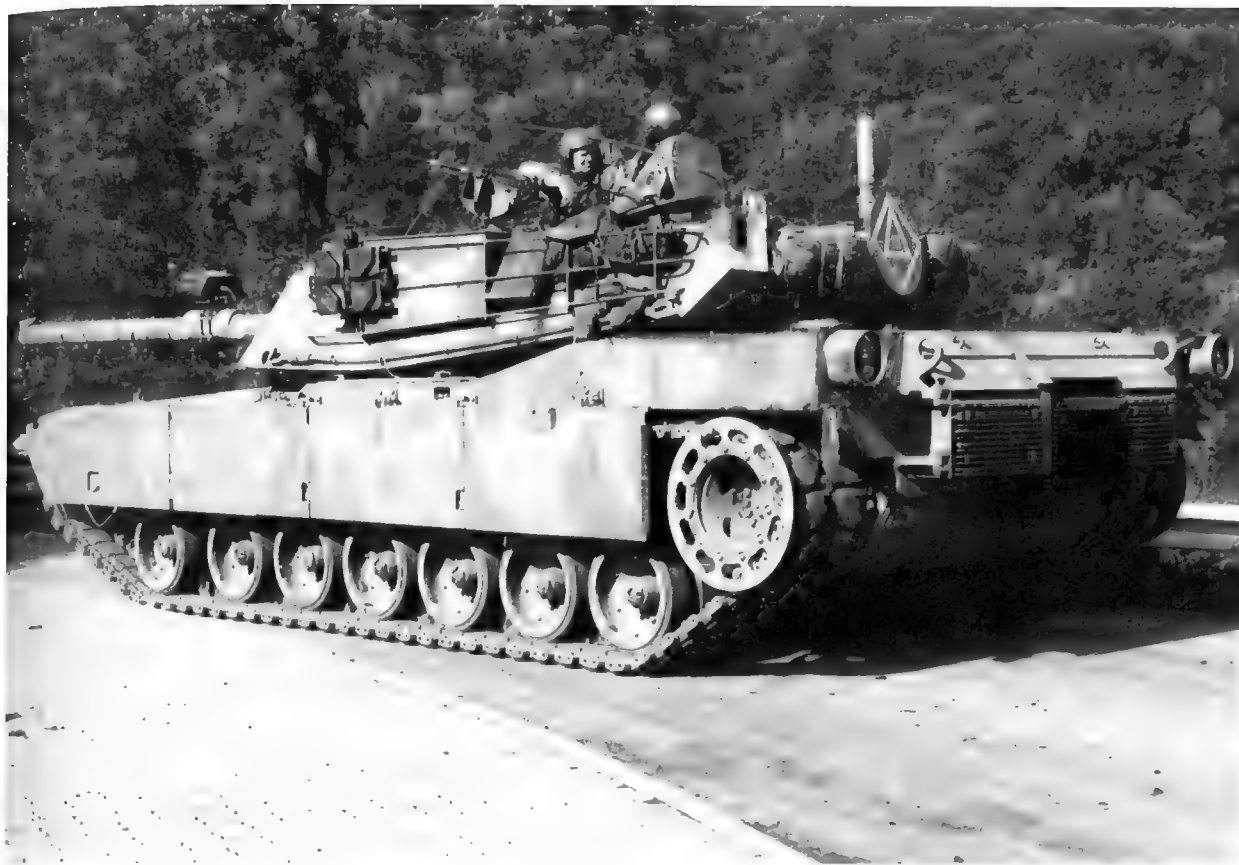
An M1 of 1/11 ACAV during 'Reforger '83'. The mud camouflage, applied to confuse opponents into thinking the M1s were German, varied from tank to tank. (Pierre Touzin)

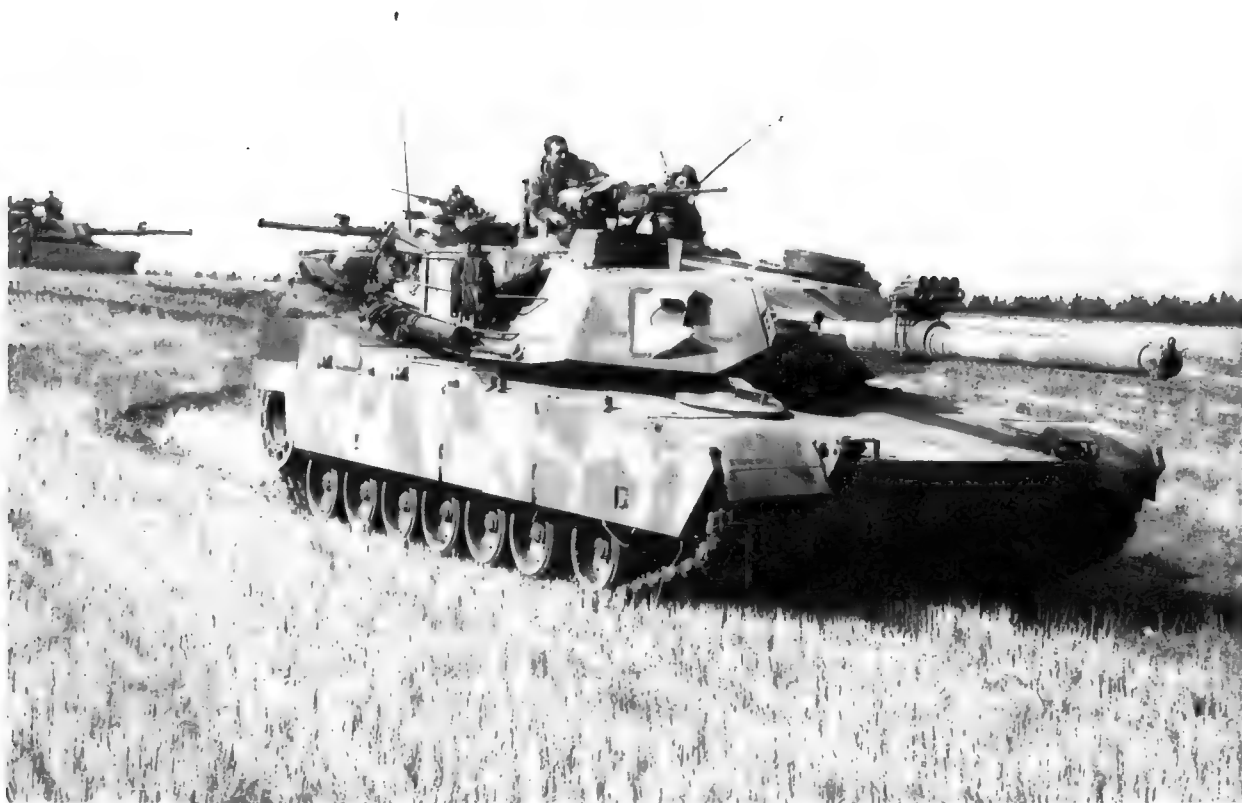
An M1 of 1/11 ACAV in 'Reforger '83' with its Blue Army marking ripping off. The narrow band across the lower edge of the turret sides and front is a Velcro strip used to attach the MILES laser training system. This tank is fitted with a pyrotechnic simulator over the barrel, which simulates the tank gun firing during exercises. (Pierre Touzin)

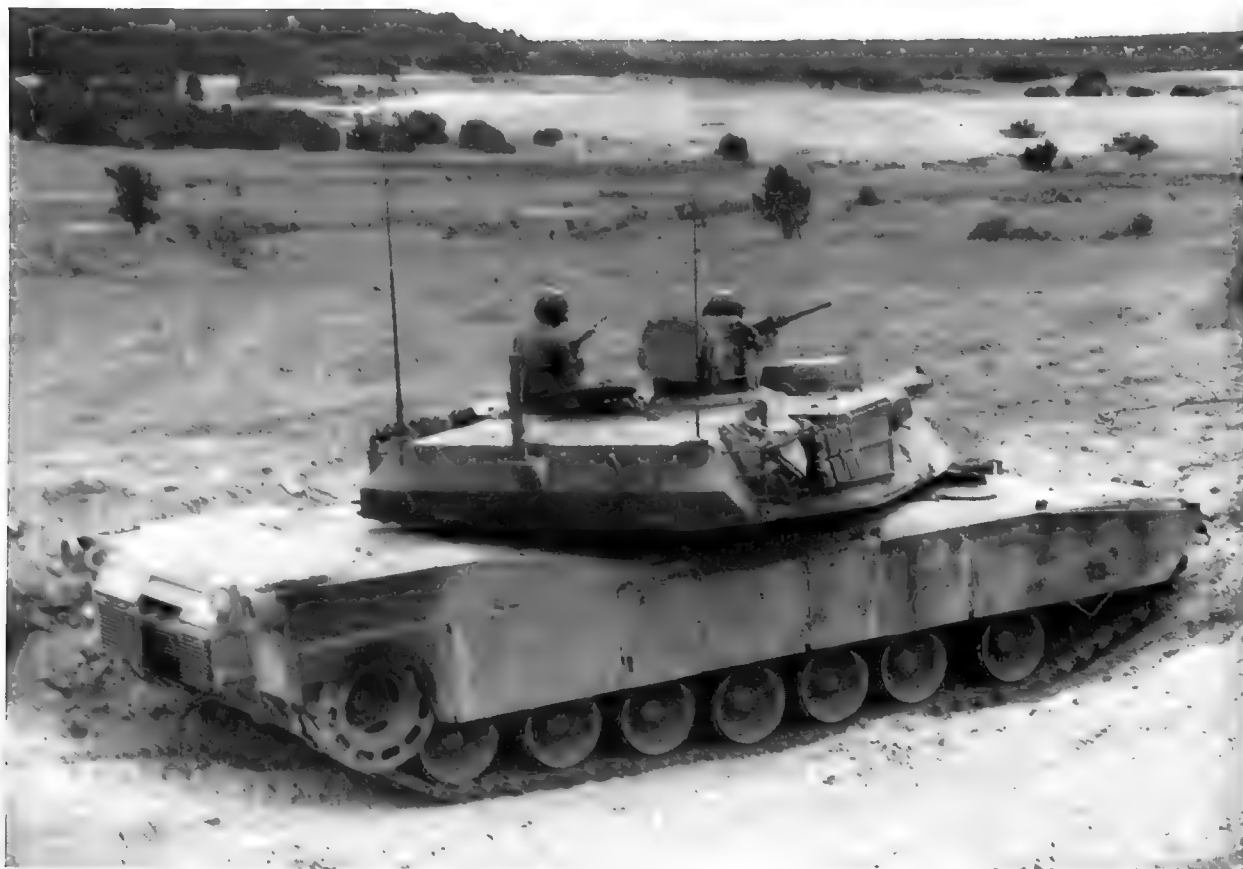
The new Div-86 tank platoon has four tanks which operate in pairs. In this view of 2nd Armd. Div. exercises on the Texas prairies, two M1s (one outside the photo) stand overwatch positions behind terrain features with only their turrets exposed, while the other pair of Abrams, in the upper right of the photo, move forward at top speed. (S. Zaloga)

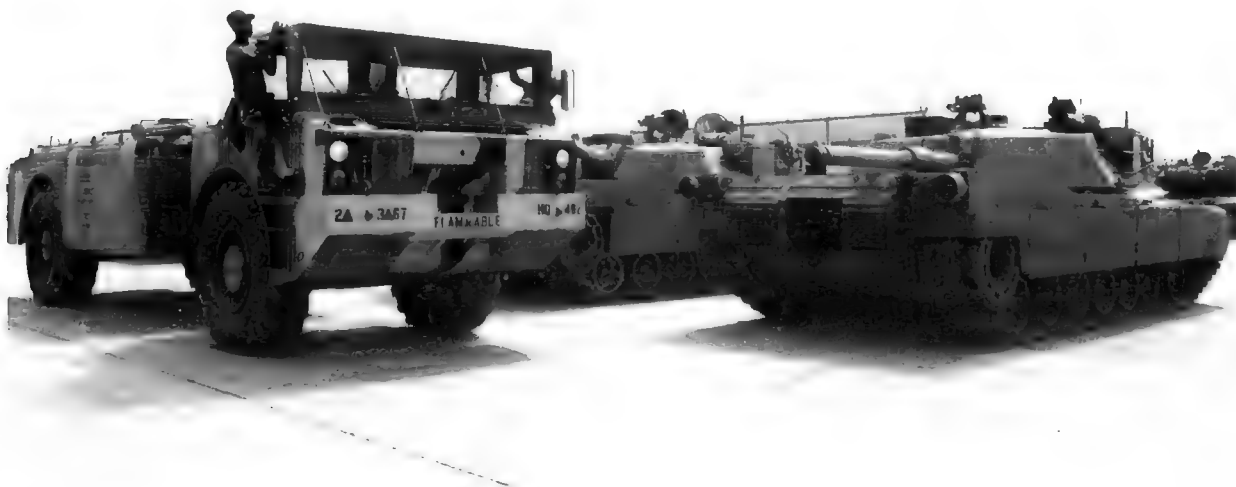
M1s being refuelled by M559 Goers. The Goers will eventually be replaced by the newer HEMTT 10-ton trucks. A single fuelling of the M1 gives it over 200 miles range, depending on terrain, which is about the same as the M60A3. (S. Zaloga)

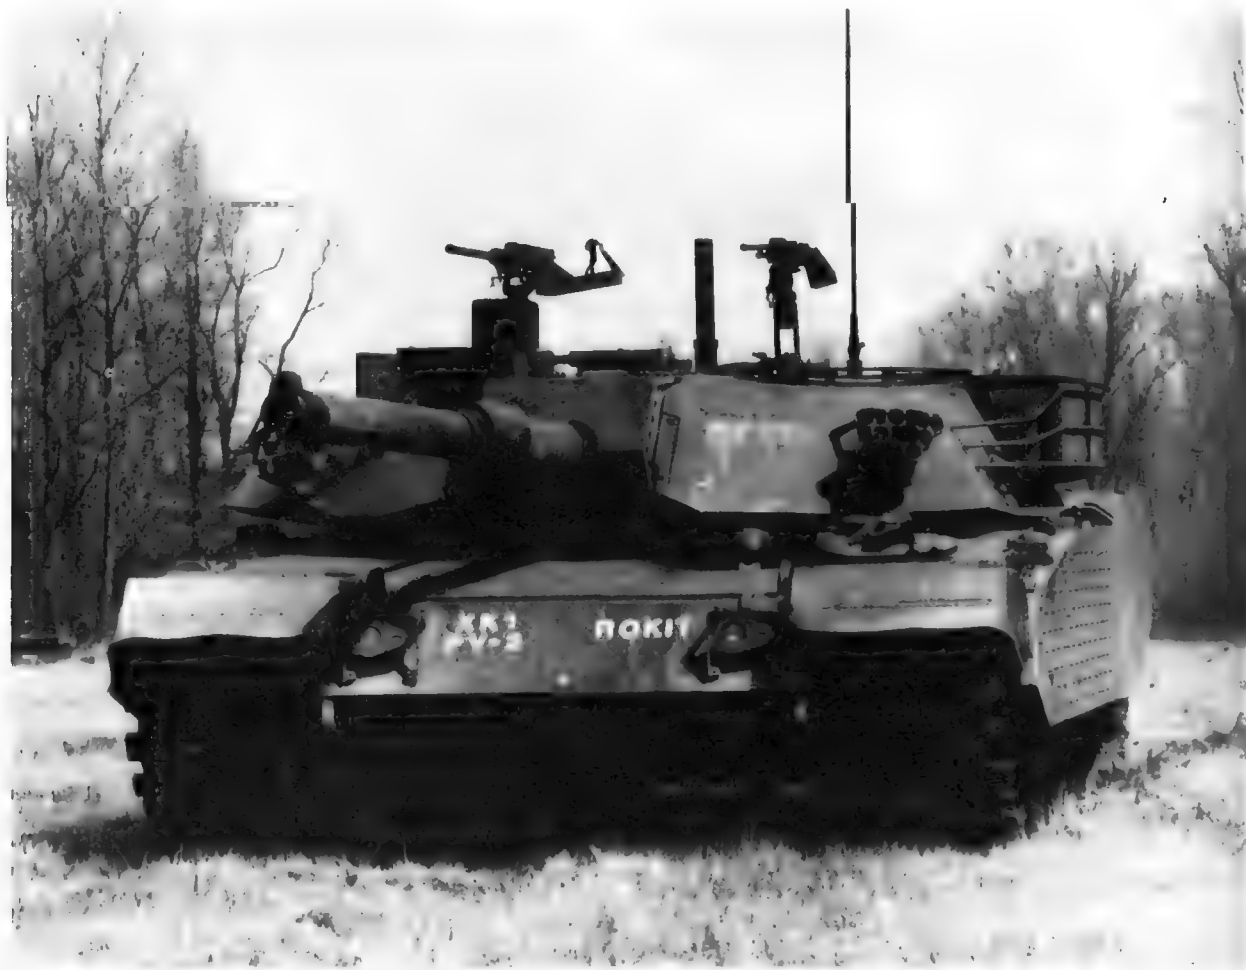
An M1 look-alike is the South Korean XK1 ROKIT tank, developed in the USA by GDLS for production in Korea. It is about two-thirds the size of the M1, and is noticeably smaller inside. (APG Public Affairs)

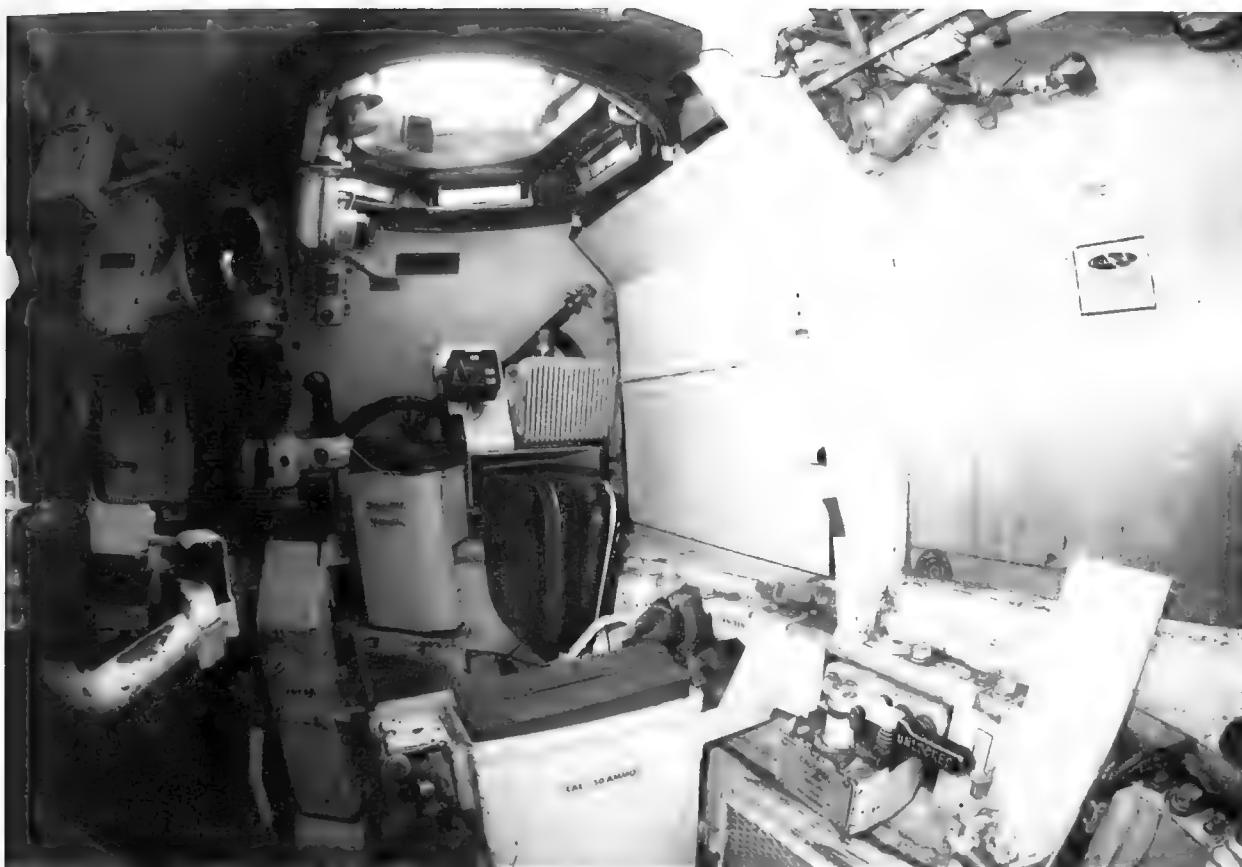
The 'business office' of the commander and gunner in an M1. This photo was taken from the commander's seat, and the gunner's seat is in the centre of the picture. The gunner's controls consist of the two black handles, which can be twisted clockwise or counterclockwise to swing the turret, or forward and back to elevate and depress the gun. They are remarkably simple to use compared to the system in older tanks. For further details of the myriad components in this area, see Plate H and page 25. (S. Zaloga)

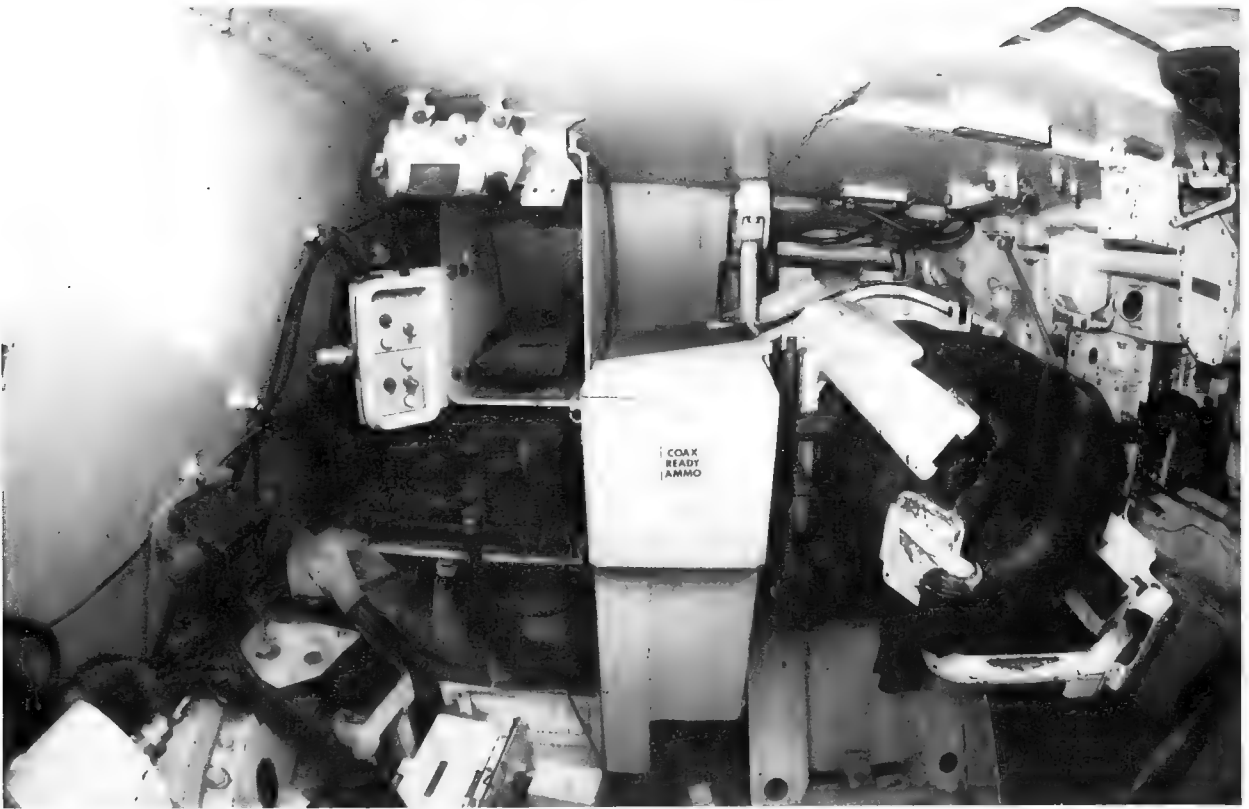
A view from the loader's station over to the commander's station. This photo clearly shows the two large blast doors which prevent ammunition fires from exploding into the crew compartment. (S. Zaloga)

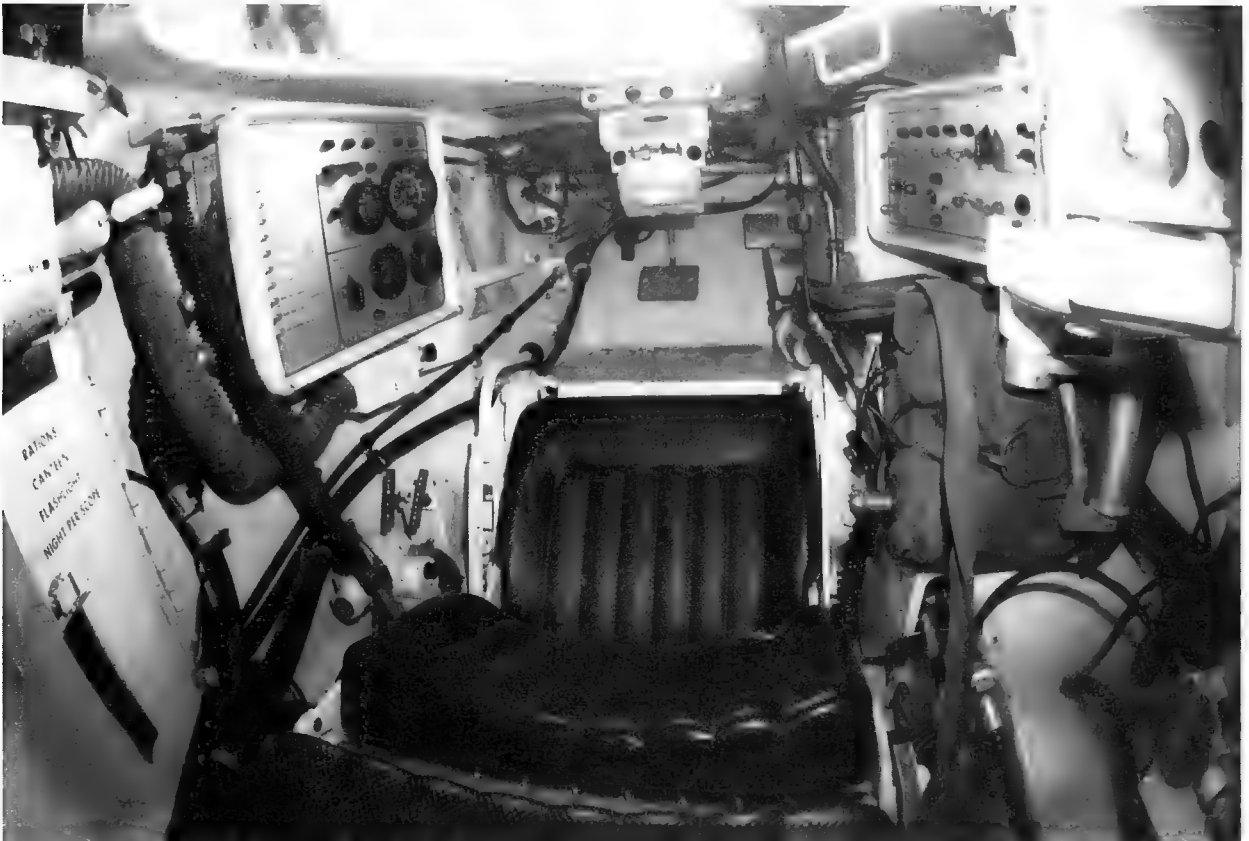
A view of the loader's station looking forward from his seat. This area contains the vehicular radios, co-axial machine gun ready ammunition, and other stowage. The breech of the M68A1 gun is very evident in this view. (S. Zaloga)

The loader's station on the M1 is well thought-out. The loader is provided with a seat due to the risks involved in standing while moving across country at high speeds. The majority of the ammunition is stowed behind protective blast doors. Should the ammunition compartment be penetrated and the ammunition ignited, the blast would be directed through roof panels instead of into the crew compartment. The doors are actuated by the loader's knee, to keep his hands free. These features are not intended to coddle the crewmen, but instead show recognition that poor tank 'habitability' degrades the rate of fire of the main gun.

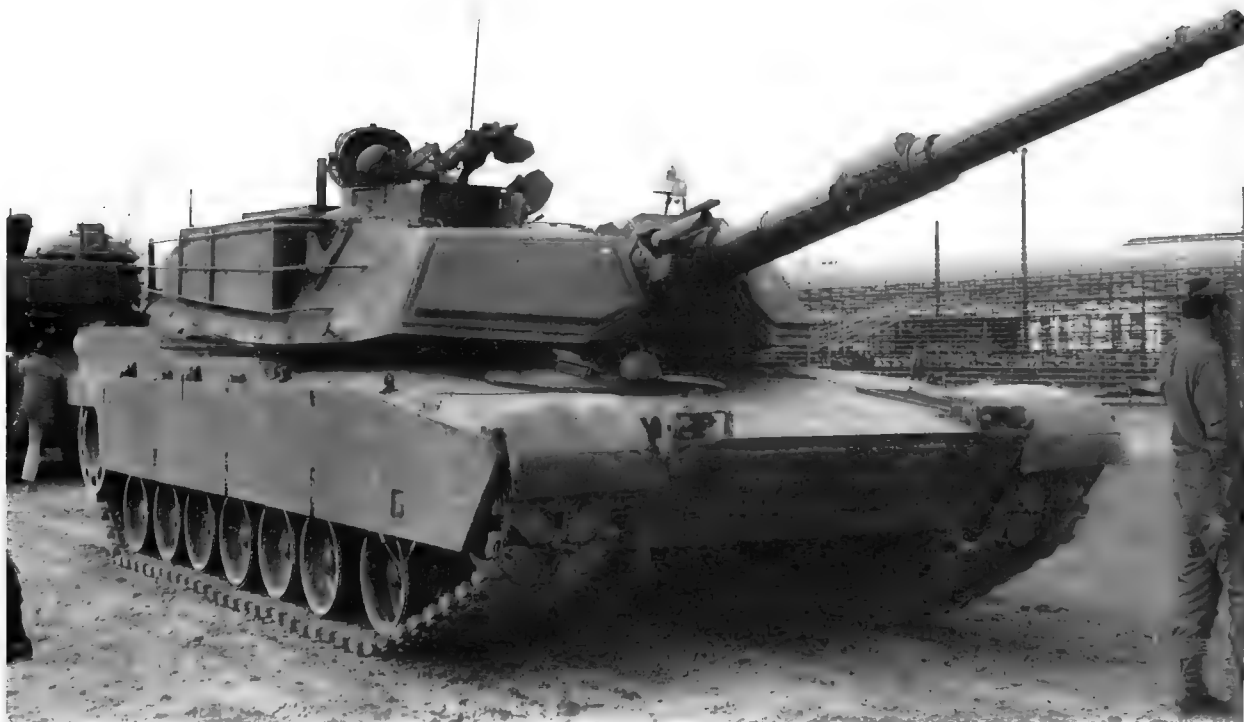
The follow-on to the M1 will be the M1E1 with the German developed M256 120 mm gun. This prototype has added armour welded to the turret and hull front to simulate the heavier armour this version will carry. When production begins in 1985, these panels will not be visible. (S. Zaloga)

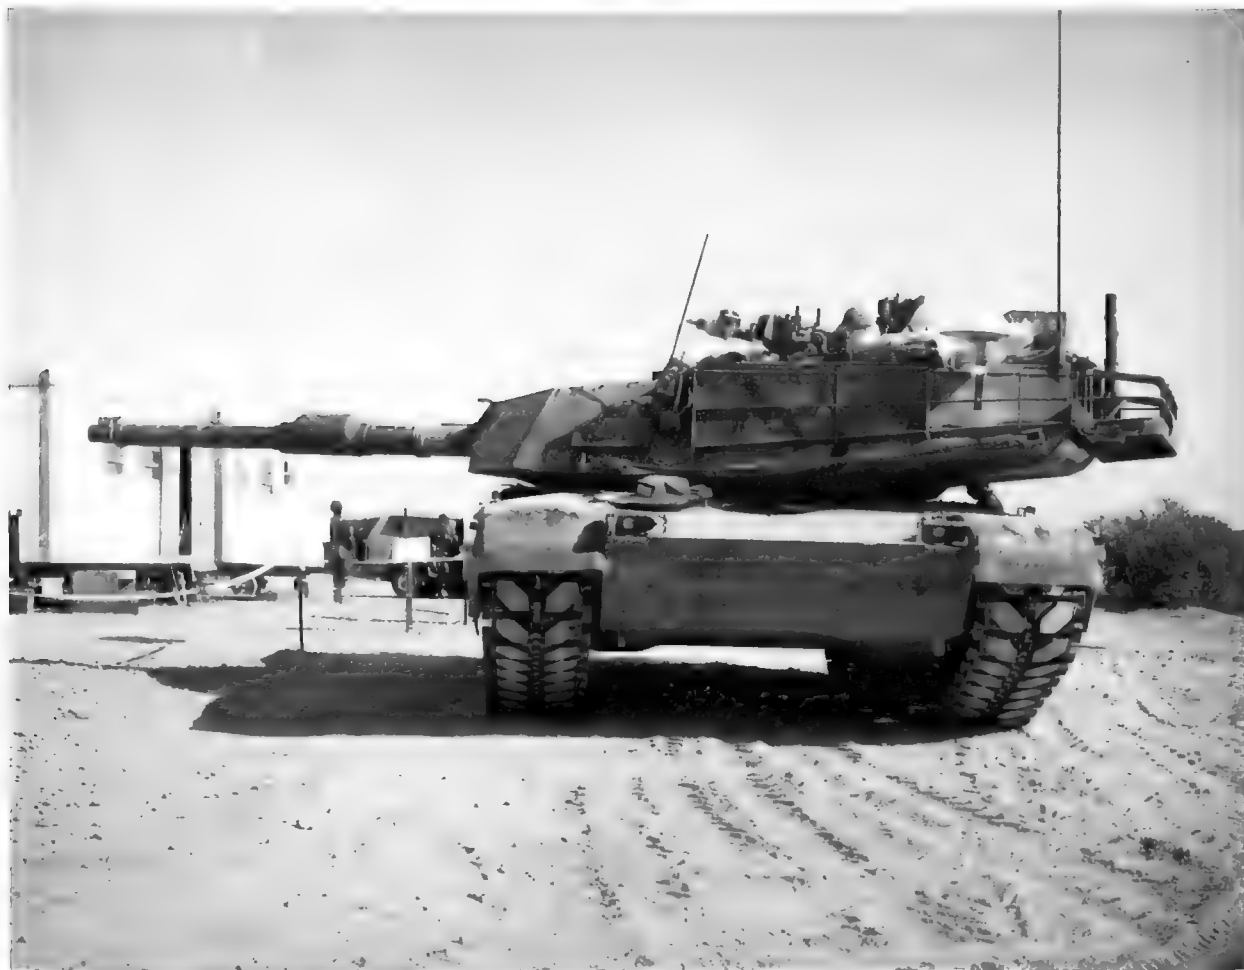
An M1E1 during operational trials at Ft. Hood in 1983. This view shows the basket assembly that has been added on the turret rear for additional stowage. The M1E1 also incorporates many internal improvements. (Ft. Hood Public Affairs)

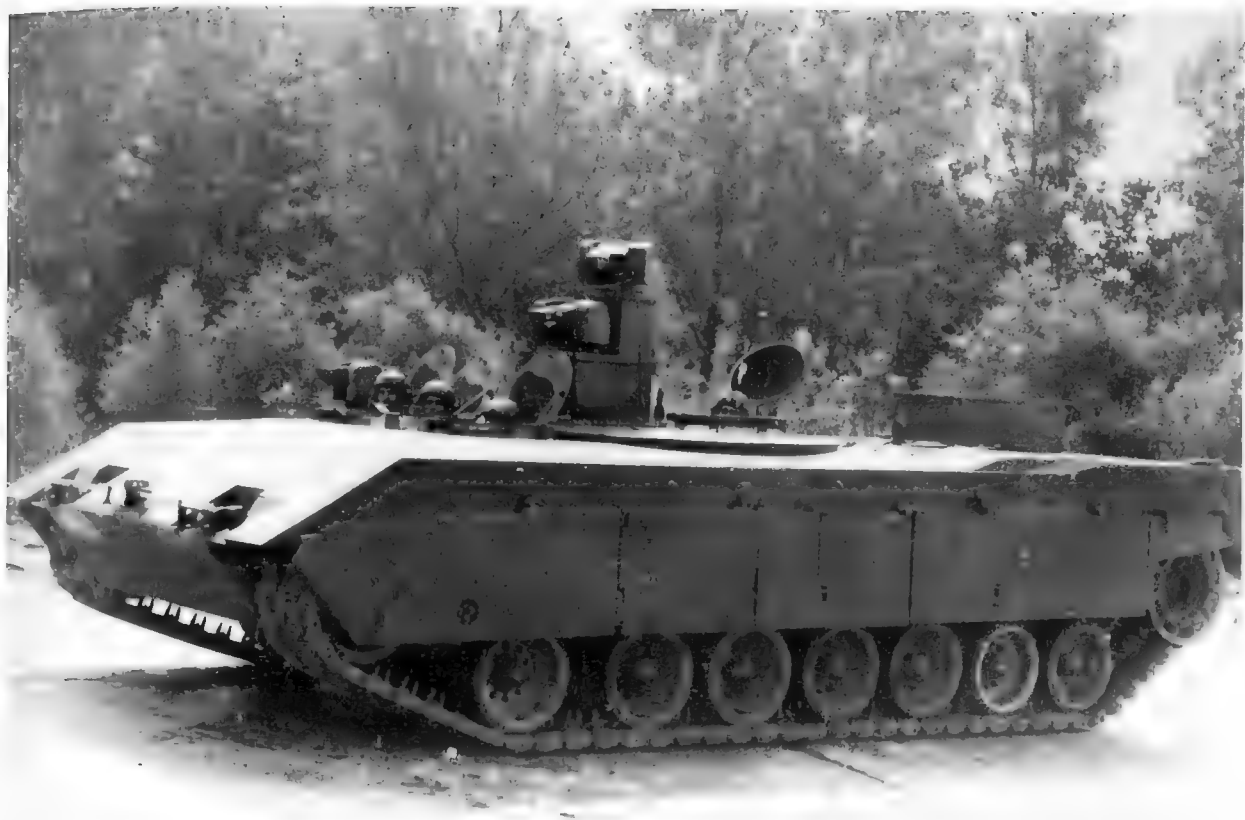
The Surrogate Research Vehicle (SRV) is an experimental version of the M1 designed to test new tank sensors and other advanced technology concepts. As is evident in this view, the vehicle has a three-man crew, with the driver, commander and gunner all in the hull. (TACOM)
